## Assessing the Causes of Defects in Heritage Building towards Safeguarding Cultural Heritage in Hausaland Milieu: A Case Study of Nasarawa Palace, Kano

Department of Architecture, Faculty of Earth and Environmental Sciences, Bayero University Kano, Nigeria

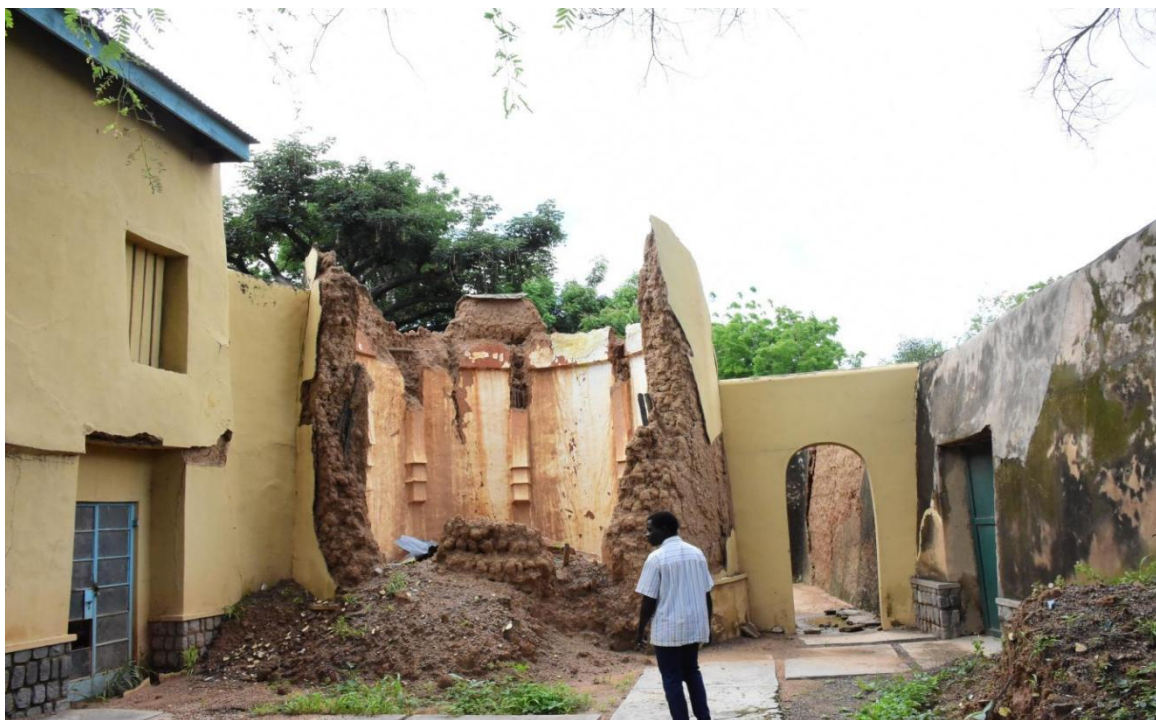
**Figure 1:** Collapsed roof of an earthen monument in the Nasarawa Palace

Rain penetrates the monuments from the roof top once there is a minute tolerance within the yabe and dabe. Subconsciously, this is where we experience a collapse in the palace due to overtime deterioration.

The rainfall curse influences the building not at once but overtime. The roof structure is the most structural component that is vulnerable to the rainfall curse as it is the most receiving point of collecting water throughout the rainy season. Despite traditional method of waterproofing is provided for protection against the rainfall, however, the excessive rainfall curse overtime penetrates the building. Once

penetrated, it will gradually contact the wooden members, azara, and begins to deteriorate and twist and loses dimension, causing structural failure in nearby future. At the same time, over the span of years, the compacted building soil also dries up and loses its plasticity. At the same time, the straw being the reinforcing material fades overtime as it decomposes by the soil reaction. These occurrences prompt the

building to lose its structural stability leading to collapse as the glutinous property of the soil has vanished, the straw has faded and the structural wood has loses its dimension (see Figure 1). Hence, excessive restoration leads to reconstruction of part thereof of the palace to avoid injuries or loss of lives. In the meantime, during the colony period around 1930s, the advent of technology and importation of modern building materials became available in Nigeria, including the Northern Nigerian cities, such as cement, zinc roofing, glass and steel doors and so on. However, the palace authorities remain sceptic in accepting and incorporating the modern building materials at first. Due to the rigor process of conservation challenges, the traditional builders began making trial and error towards incorporating the modern building materials in the Palace conservation. The following were responses of the traditional builders on the issue modernisation of the conservation processes:

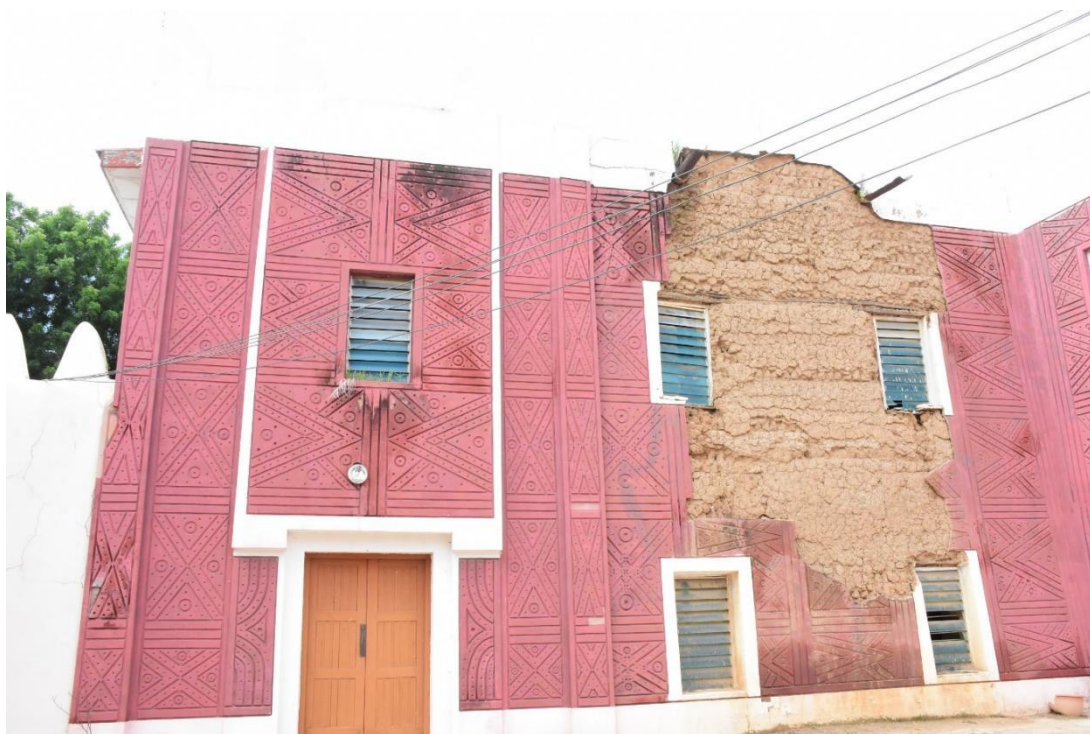
**Figure 2:** Collapsed cement plaster layer on earthen surface

allow any imported material to be incorporated in the preservation intervention of the palace earthen monuments. It was later it was finally agreed in the 1980s that such material can be integrated on the earthen monuments. The cement paste was used in form of sacrificial layer by plastering the earthen surface. However, overtime, the cement plaster layers peels-off.

The cement paste was integrated as a sacrificial layer by plastering the earthen wall surfaces purposely to protect the building from rain influence. However, this trial failed as the cement plastering buckles and forms crack over time. This is because the surface properties of the cement and that of the earthen surface are incompatible with each other. Hence, overtime due to tear and wear, the cement and the earthen surface separate apart. As the cement become swollen, it cracks due to lack of expansion tolerance. Once it cracks, rain easily penetrates and harm the monument and the plaster cements continue to deteriorate and collapse off the monument and falls (see Figure 2).

Due to the failure of the cement paste, Sandcrete hollow block wall is built upon the external surface of the earthen monument. Despite the transformation of the Nasarawa Palace over time, the palace ensured reflecting the cultural identity of the traditional architecture by reviving the cultural elements, styles and symbols in the restoration despite using modern building materials (see Figure 3). This process balance between preserving and restoration in the conservation processes. The palace has managed to maintain its historical essence while incorporating the modern building materials Due to the causes of the deterioration that leads to collapse and tedious maintenance, the monuments are rebuilt using completely with modern building material but reviving the cultural elements (see Figures 4 & 5):
